ASI/PINSON 1kW HIGH RELIABILITY
WIND SYSTEM

Phase II
Prototype Construction and Testing

July 1981

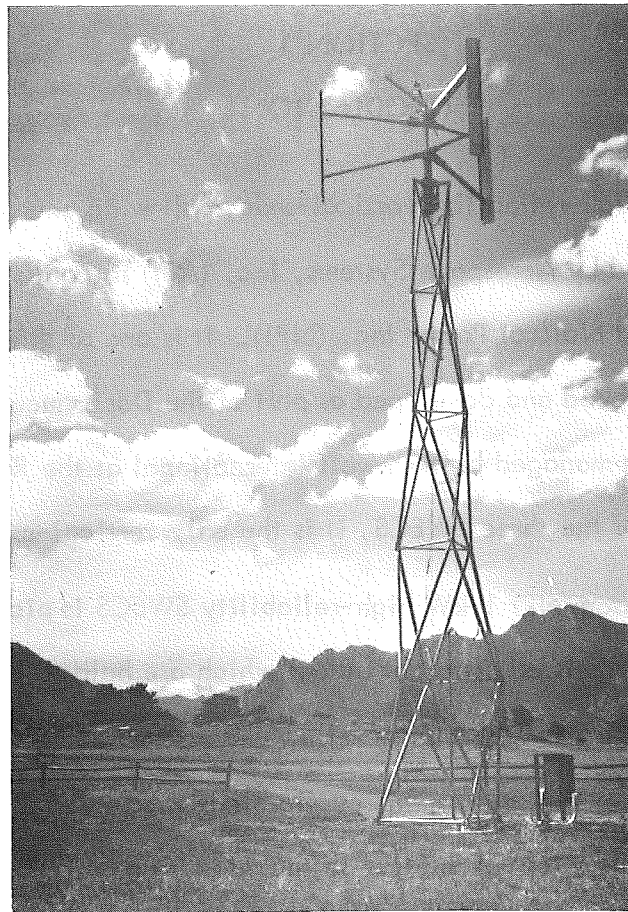
Figure 1. ASI/Pinson/NPI 1-kW High-Reliability SWECS.

The SWECS as shown in Figure 1 is basically the same as approved at the Phase I Final Design Review. The most noticeable change is the replacement of the approved tail/wing vane with the V-vane configuration. A 42.5-ft Octahedron tower was approved for installation at the Rocky Flats Wind Systems Test Center (WSTC). Additional effort was approved in Phase II for the installation of instrumentation on the

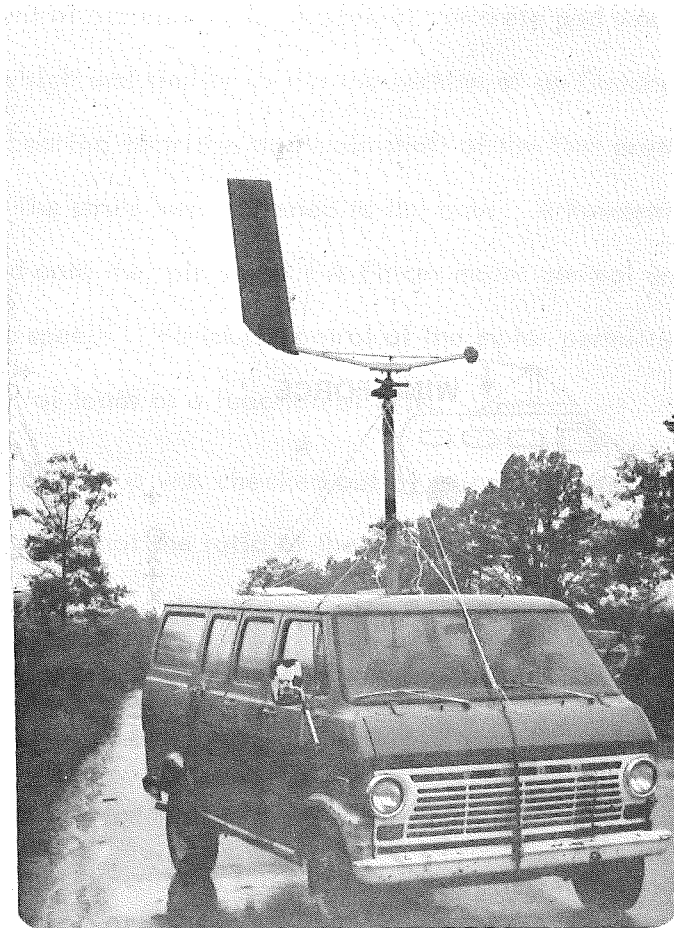
Figure 37. Test Setup for V-Vane.

Tests were conducted on the V-vane to determine its aerodynamic lift characteristics. The V-vane was mounted on the top of a truck as shown in Figure 37. The vane was tufted in order to observe the flow pattern on the underside of the vane (see Figure 10). Force on the V-vane was transmitted inside the truck through a rod connected to a scale system. A series of runs were conducted at speeds up to 35 MPH. Flow over the vane appeared to be smooth. Initial tests were repeated since wind gusts were encountered. Data obtained during the tests are included in Figure 38. It was concluded

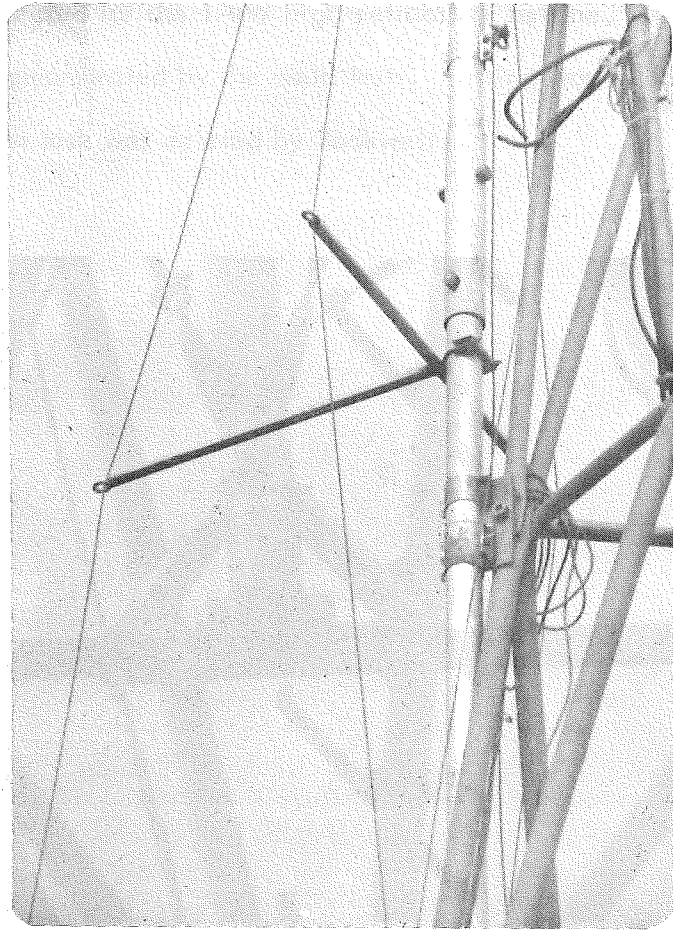
a) Installed Davit; (Note Parted Cable)

Figure 46. Prototype Aluminum Davit Installation.

b) Crane

c) Tower Attach Point; Bracing
Stays and Cables

d) Davit Foot Clamped to Tower

The prototype aluminum davit, which incorporated changes tested on a steel version, was fabricated and tested. A weight of over 500 pounds was lifted and hoisted using the electric winch almost to the top of the tower. A steel support cable which provided tension support to the davit boom was overstressed and parted. An oscillation
